## Study on the glued joints of historical glued laminated timber

**Gunter LINKE**

Ingenieurbüro Rug GmbH

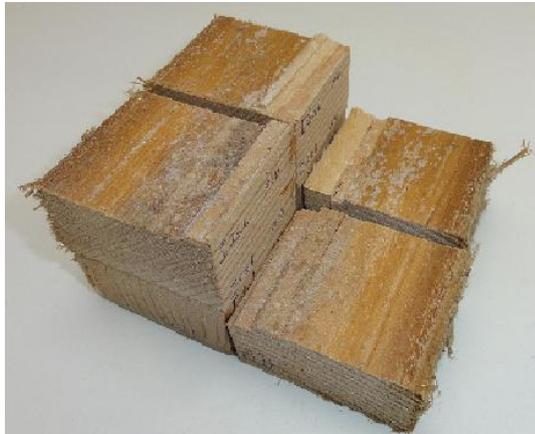
The specimen showed clearly visible signs of maceration on their surface. This included amongst

**Fig. 2:** crystalline sediments in the glued joints

others a greyish brown discoloration as well as the defibration of the wood structure near the surface. The glued joints on the chords were partially open and coated with crystalline sediments (see Fig. 2).

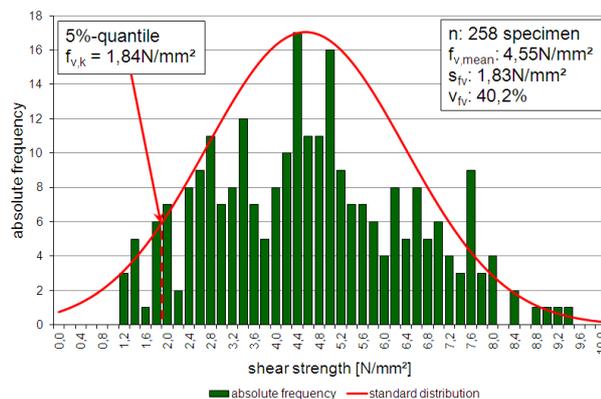
**Fig. 3:** distribution of the shear strength

The shear strength of the glued joints varied between 1,1...9,4 N/mm<sup>2</sup>. The relatively large span width of 8,3 N/mm<sup>2</sup> is also confirmed by the variation coefficient with a value of 40,2%. The 5%-quantile of the shear strength measured 1,84 N/mm<sup>2</sup>.

The average shear strength was determined with a value of 4,3 N/mm<sup>2</sup> (chords) and 4,9 N/mm<sup>2</sup> (web). The average fiber fracture ratio measured 59%.

A comparison of the results with the data of directives of the use of casein glue in the production of wooden aircrafts of the 1930s and 1950s revealed, that the average shear strength of the specimen corresponds approximately with the listed minimum strength of (5,1...5,5) N/mm<sup>2</sup> (see [3] & [4])
