NATIONAL HERITAGE FOUNDATION
2018 Conference – Serbia

Redevelopment of a wooden roof construction under preservation order – strength grading of the timber members

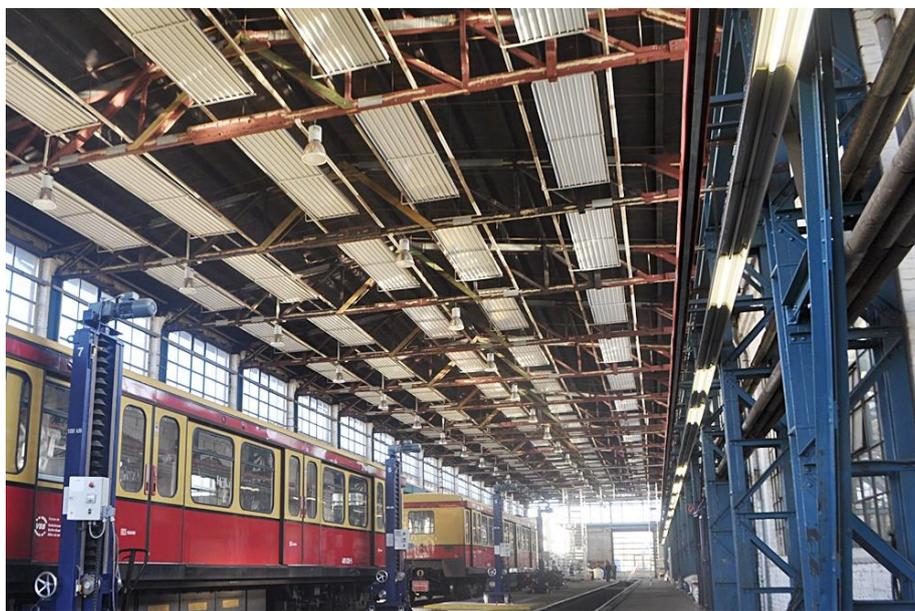
Fig. 1.1 wooden roof construction of a storage and repairing facility from the 1950s, the redevelopment required the comprehensive evaluation of the building conditions

The considerate redevelopment of existing timber structures requires a high standard of care and accuracy in all phases of planning and execution. To enable a substance-careful redevelopment, a detailed structural survey is required (see Fig. 1.1). In addition to the structural geometry, this also includes an exact assessment of the stability (Lißner & Rug, 2015 and 2018).

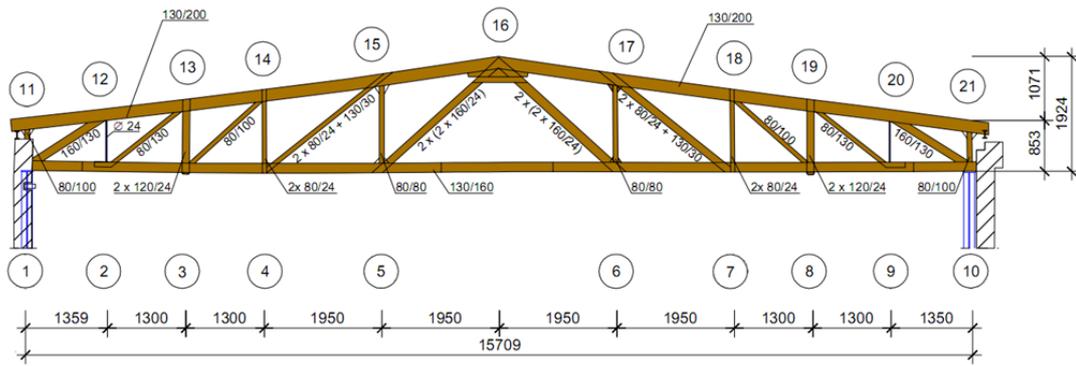
Fig. 2.1 graphic depiction of the timber trusses

The investigated roof construction is part of a storage and repairing facility. The roof construction was erected in the 1950s and consists of 21 timber trusses with a span width of 15,7 m (see Fig. 2.1).

The connections between the members are executed as carpentry joints (staggered joints and tenons) as well as nailed and bolted joints (partially with rectangular hardwood dowels).

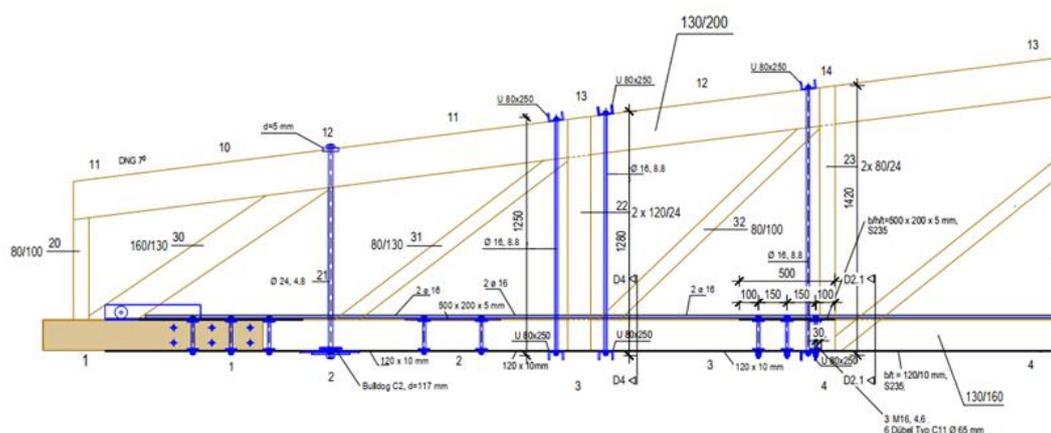
Fig. 2.2 Detail of the preliminary redevelopment solution (marked blue: reinforcement)

The results of the preliminary investigations showed the necessity of a reinforcement of the timber trusses. Overall, the condition of the roof construction was evaluated as “poor”. The structural engineer’s redevelopment solution intended the reinforcement of the bottom chords with steel belts. Additionally, the tension rods (originally lateral boards with nailed joints) should be replaced with threaded rods due to the poor state of the nailed joints (see Fig. 2.2).

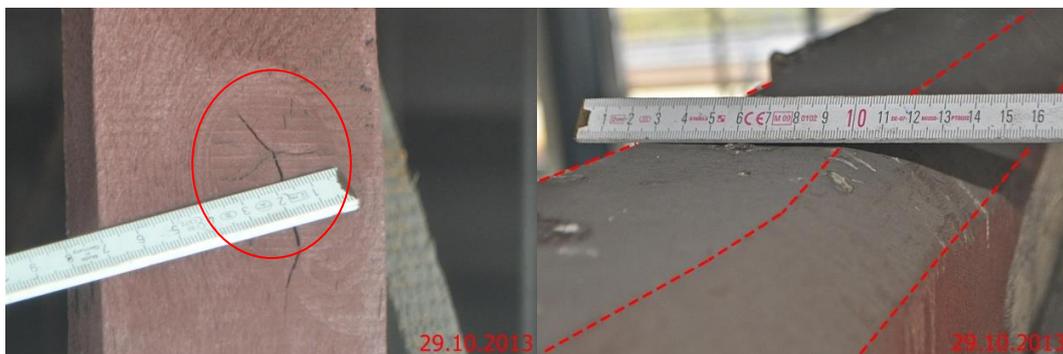
Fig. 3.1 measuring of grading criteria – left: knots; right: wane

The timber members of the trusses were visually graded acc. DIN 4074-1:2012. Due to the partial restricted accessibility and visibility only, the following grading criteria have been taken into account: knots, slope of grain, cracks, wane, curvature, decay and damage caused by insects (s. Fig. 3.1, Fig. 3.2). The grading criteria pith, width of annual rings, discolouration and compression wood could not be considered.

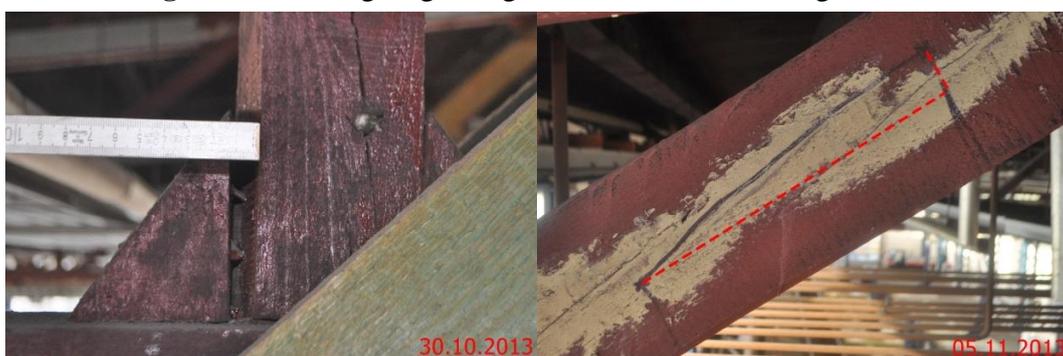
Fig. 3.2 measuring of grading criteria – left: torsion; right: slope of grain

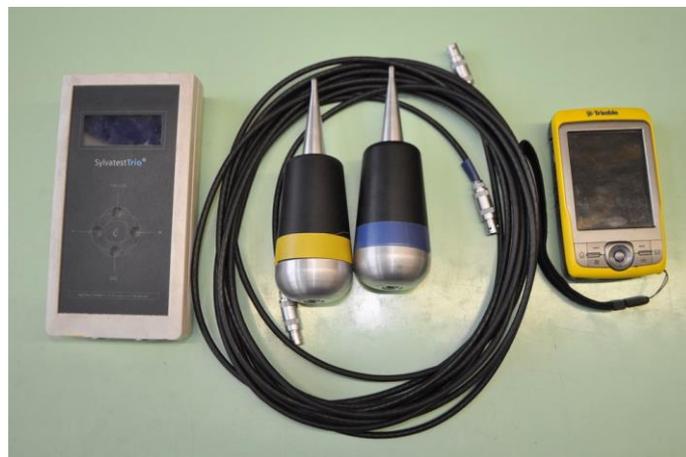
Fig. 3.3 apparatus for the ultrasonic time-of-flight measurement (left to right: test apparatus Sylvatest Trio[®], emitter/reciver probes and cables, handheld PC with evaluation software)

The ultrasonic time-of-flight measurements were carried out with the test apparatus Sylvatest Trio[®] (see Fig. 3.3). This apparatus generates an ultrasonic pulse and measures the time which the pulse needs to travel from the emitter to the receiver.

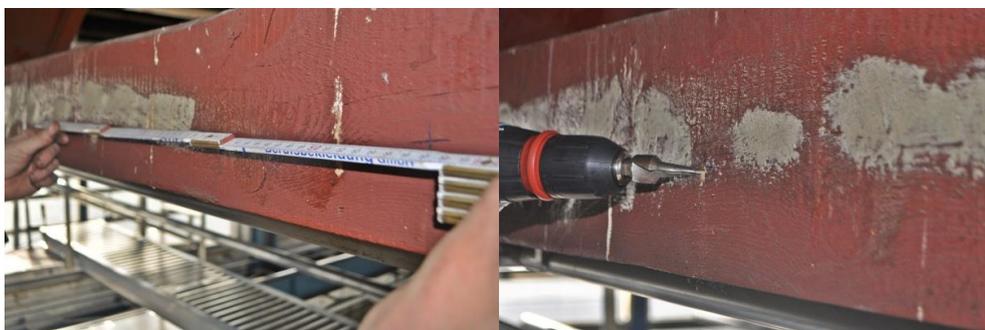
Fig. 3.4 procedure of the ultrasonic time-of-flight measurements – definition of the measuring zone (left), drilling of the holes for the probes (right)

The measurements were carried out on the top and bottom chords as well as the compression rods (see Fig. 3.4 & 3.5).

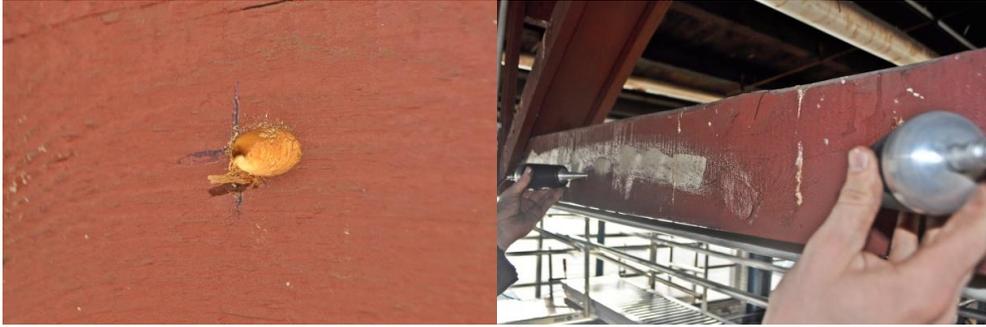
Fig. 3.5 procedure of the ultrasonic time-of-flight measurements – conical hole for the probes (left), measuring of the time-of-flight (right)

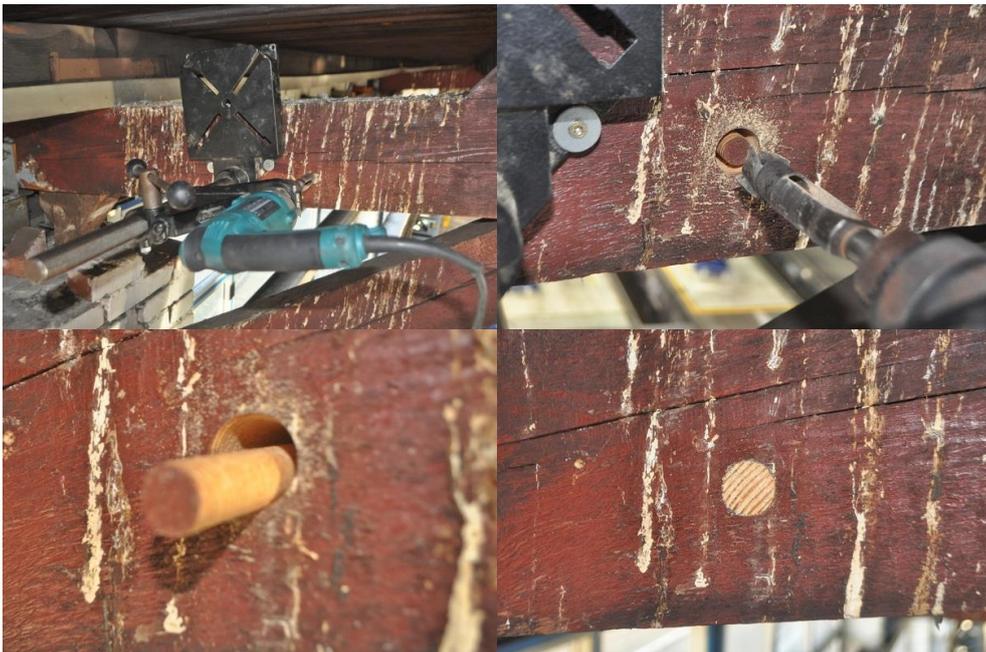
Fig. 3.6 procedure of core drill sample extraction – fixing of the drilling jig on the timber member (top left); core drilling (top right); extracted sample (bottom left); sealing of the hole with a wooden dowel (bottom right)

In addition to the visual grading and the ultrasonic time-of-flight measurements core drill samples have been extracted from selected members of the trusses (see Fig. 3.6).

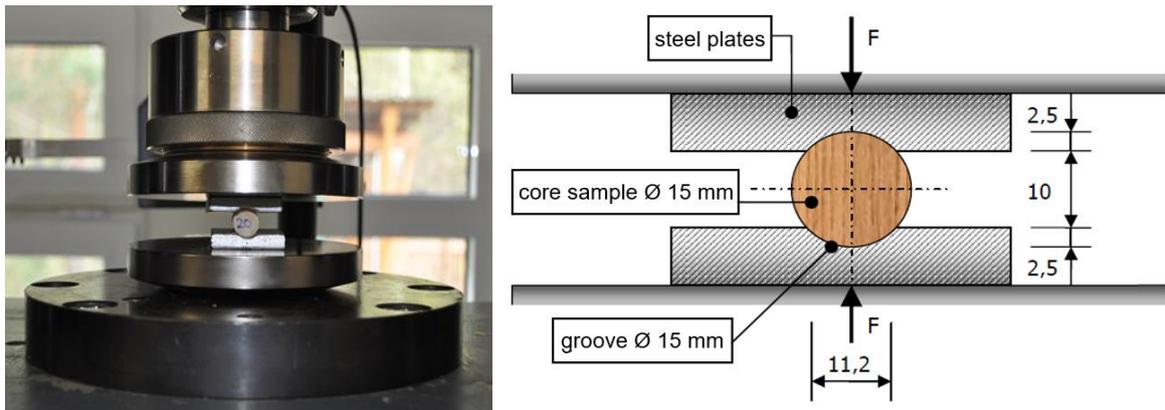
Fig. 3.7 test setup for the determination of the compression strength on core drill samples

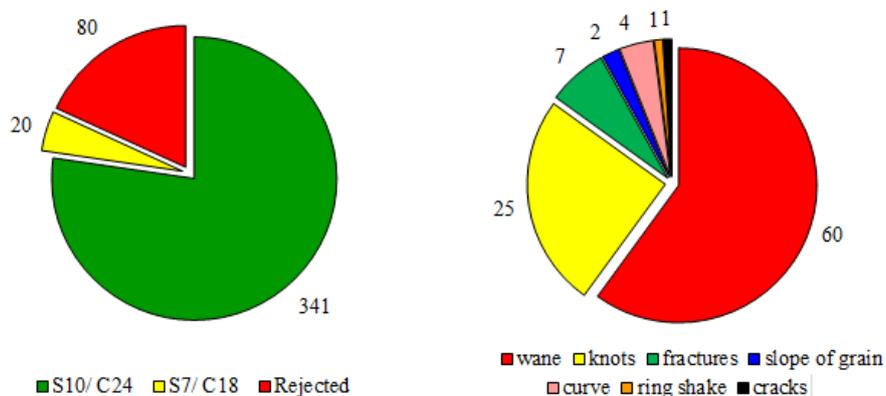
The results of the visual grading show that only one truss can be completely assigned at least to the class S10 acc. DIN 4074-1 resp. to the class C24 acc. EN 338. Overall, there were 100 from 441 visually graded timber members which could not be assigned to the class S10 acc. DIN 4074-1. 20 of these 100 members can be assigned to the class S7 acc. DIN 4074-1 resp. class C18 acc. EN 338. The remaining 80 members could not be assigned to any class acc. DIN 4074-1 and EN 338.

Fig. 4.1 Results of the visual grading – left: Distribution of the grading yield rate; right distribution of the determining grading criteria

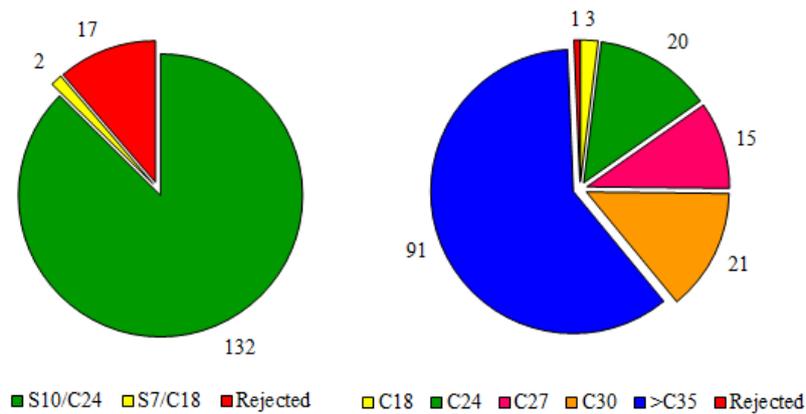
Furthermore, it was revealed that 127 out of 235 members could be assigned to a higher class on basis of the ultrasonic time-of-flight measurements than on basis of the visual grading (see Fig. 4.2).

Fig. 4.2 Results of the visual grading (left) and the ultrasonic time-of-flight measurements (right) in comparison

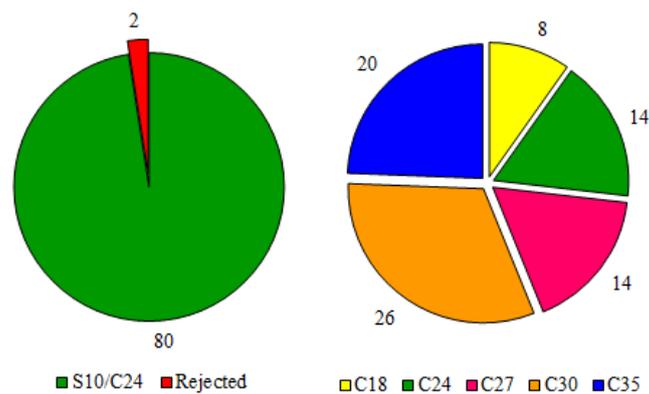
This result was verified by the results of the laboratory test on the extracted core drill samples. As shown in Fig. 4.3, 60 out of 82 investigated members could be assigned to a higher class than purely on basis of the visual grading.

Fig. 4.3 Results of the visual grading (left) and the laboratory tests on the core drill samples (right) in comparison
