## Study on the glued joints of historical glued laminated timber

**Gunter LINKE**

Ingenieurbüro Rug GmbH

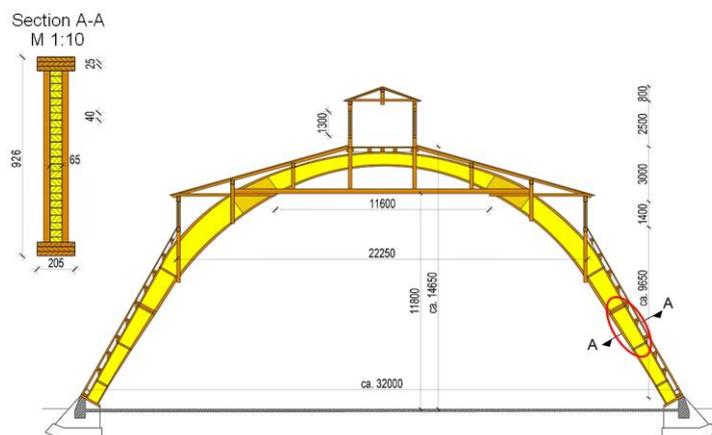
The studies have been carried out on specimen, which were taken from the timber structure of a warehouse for potassium salt (see Fig. 1). The warehouse was constructed in 1912 with the help of the Hetzer construction method. At the time of the studies the glued joints were nearly 100 years old (see [1]).

**Fig. 1:** View on the timber construction; the surveyed area is marked red
